## Joshimath Land Subsidence

### What is the Joshimath Issue?

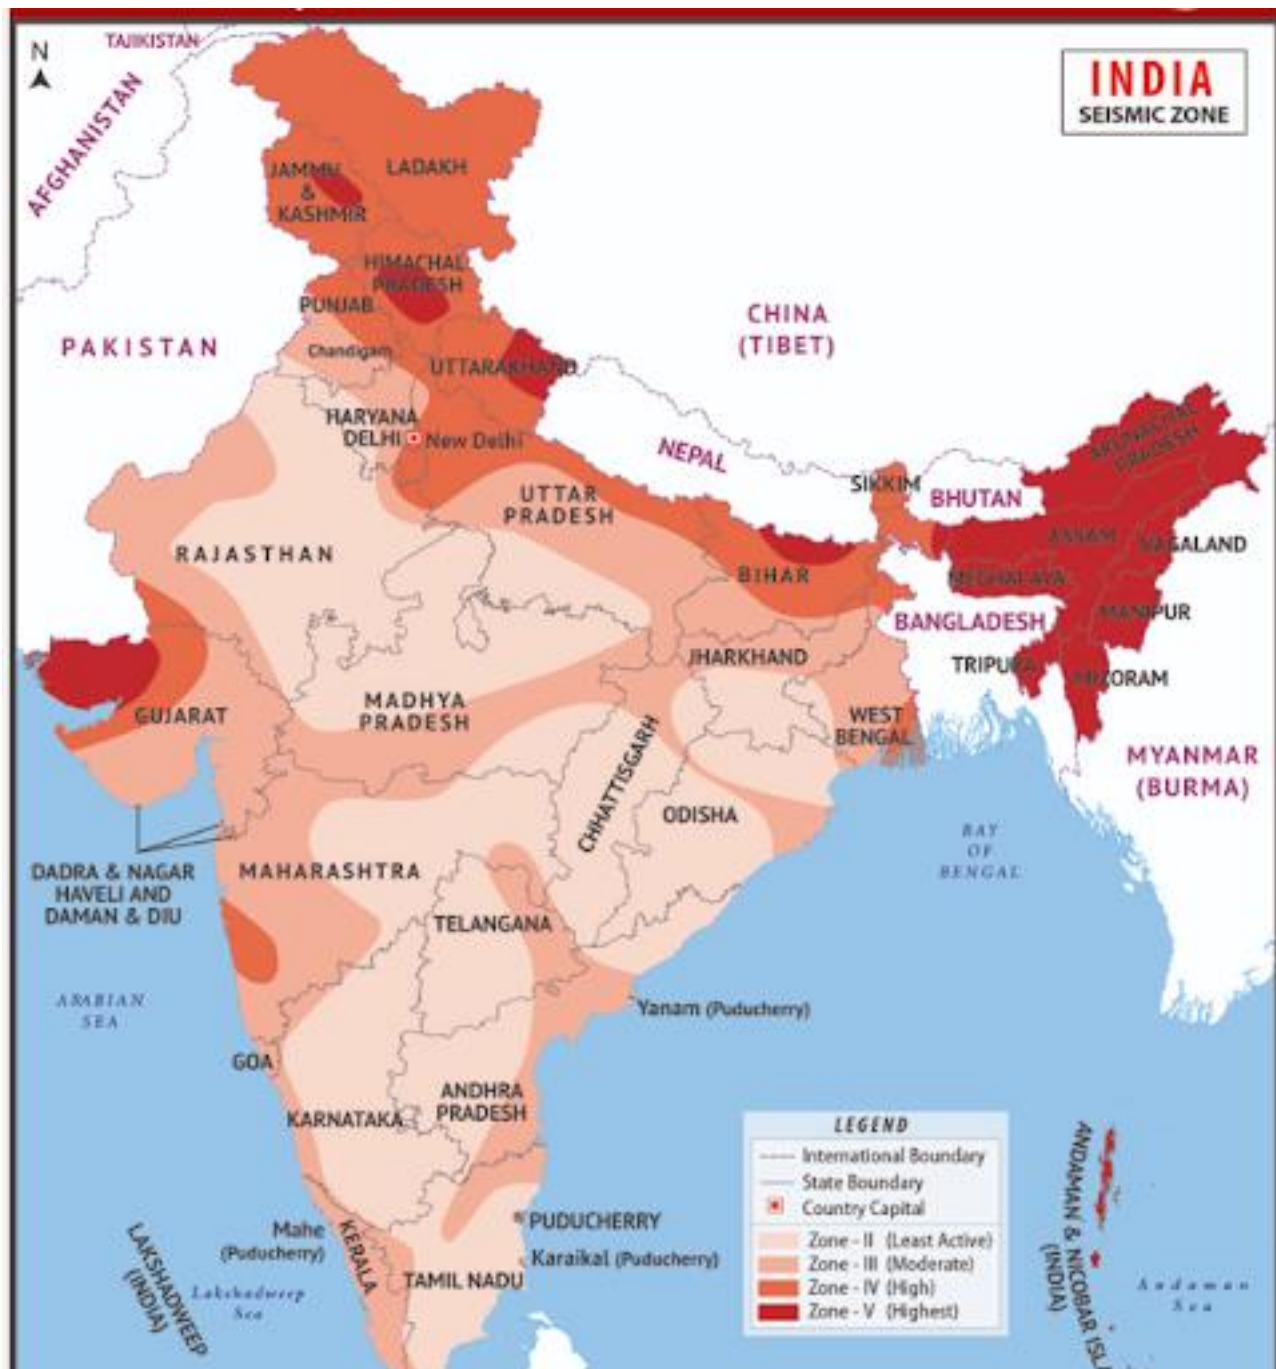
### **Seismic mapping in India:**

- The National Centre for Seismology under the Ministry of Earth Sciences is the nodal agency of the Government of India (GoI), for monitoring earthquakes in and around the country.
- As per the seismic zoning map of the country, the total area is classified into four seismic zones.
  - Zone V is seismically the most active region.
  - Zone II is the least.

- 11% of the country falls in zone V, 18% in zone IV, 30% in zone III and the remaining in zone II.
